**AFRL-ML-TY-TR-2002-4514**

## **FIRE PROTECTION FOR MUNITIONS IN UNDERGROUND STORAGE FACILITIES**

**FINAL REPORT FEBRUARY 2001 – MAY 2001**

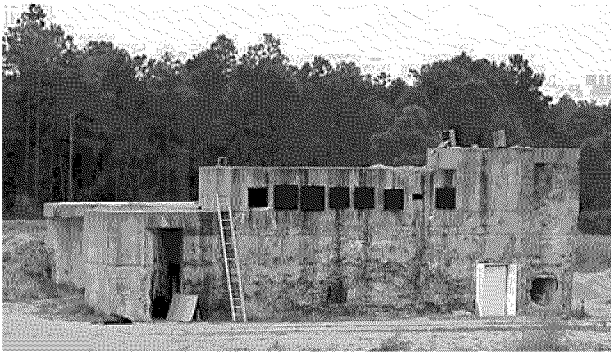
Figure 1: NATO Facility

The preparation process for this series of tests involved retrofitting the NATO facility (Figure 1) at Test Range II Tyndall AFB, FL to the likeness of an underground munitions storage facility. The room, shown in Figure 2, where tests were conducted is 31 feet x 55 feet (9.5m x 17m), with a ceiling height of 14 feet (4m). The facility floor was lined with 3/8 in (0.95 cm) steel to contain the test effluent. A sprinkler system was installed along with a 2000 gpm (7570 lpm) centrifugal water pump specifically leased for this purpose. The facility was instrumented with four video cameras, one IR video camera, thermocouples, two Detector Electronics Unitized UV/IR optical flame detectors (see Figure 3), a water flow meter and a data acquisition system. Exhaust fans were remotely controlled with the data acquisition system.
